**A STUDY OF THE USE OF VIBRATION AND STRESS WAVE  
SENSING FOR THE DETECTION OF BEARING FAILURE**

ENGINEERING REPORT NO. 75-18 C

National Aeronautics and Space Adminis-  
tration, George C. Marshall, Space Flight  
Center, Huntsville, Alabama 35812

ENDEVCO  
San Juan Capistrano  
30 September 75

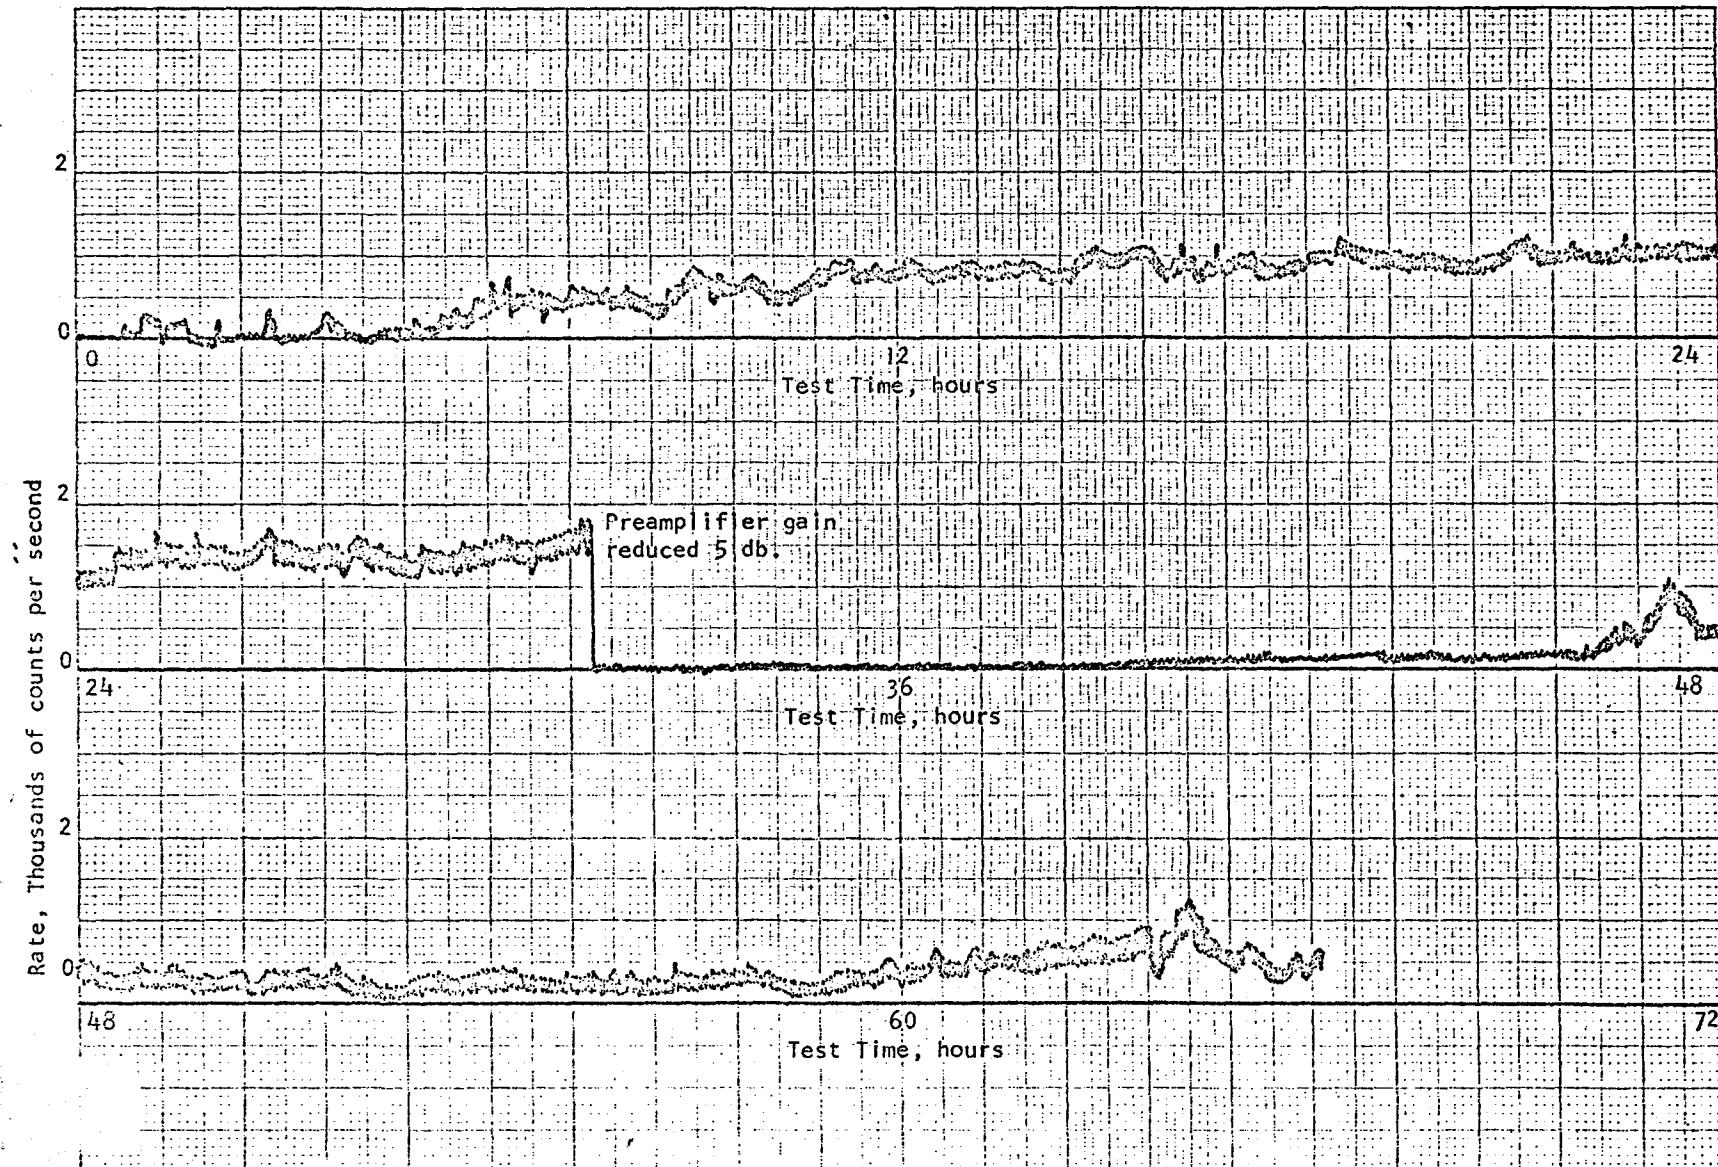
The count rate data had changed gradually during the first 24 hours of test one by a factor of about ten and an additional factor of ten over the next 23 hours prior to the large indication discussed above. It is not known if the gradual increase in count rate is indicative of crack propagation, stress waves, or impacts increasing in magnitude as the

Figure 24- Reproduction of count rate data from Endevco® Model D9202 Acoustic Emission/Stress Wave Sensor with Model 301 Totalizer on fatigue test run number one, bearing number 13.

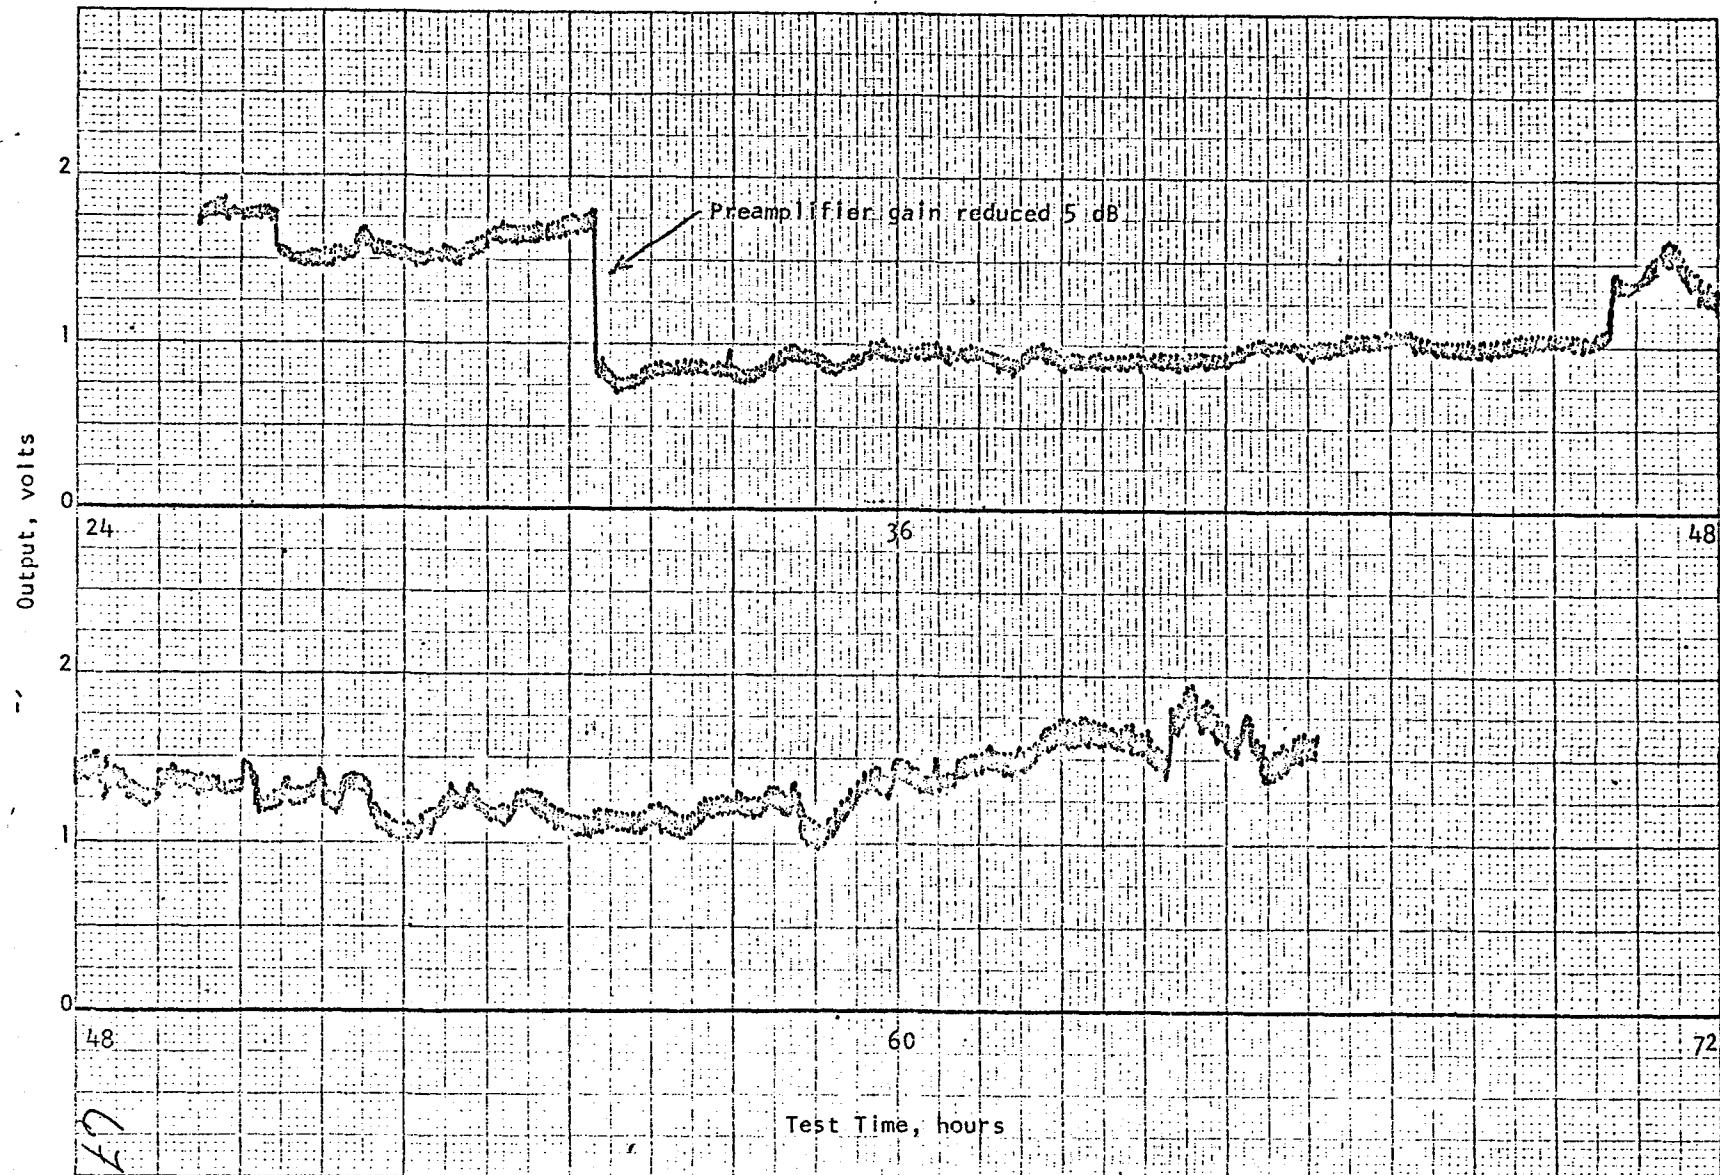
Figure 25 - Reproduction of peak envelope detected data from Endevco® Model D9202 Acoustic Emission/Stress Wave Sensor on fatigue test run number one, bearing number 13.

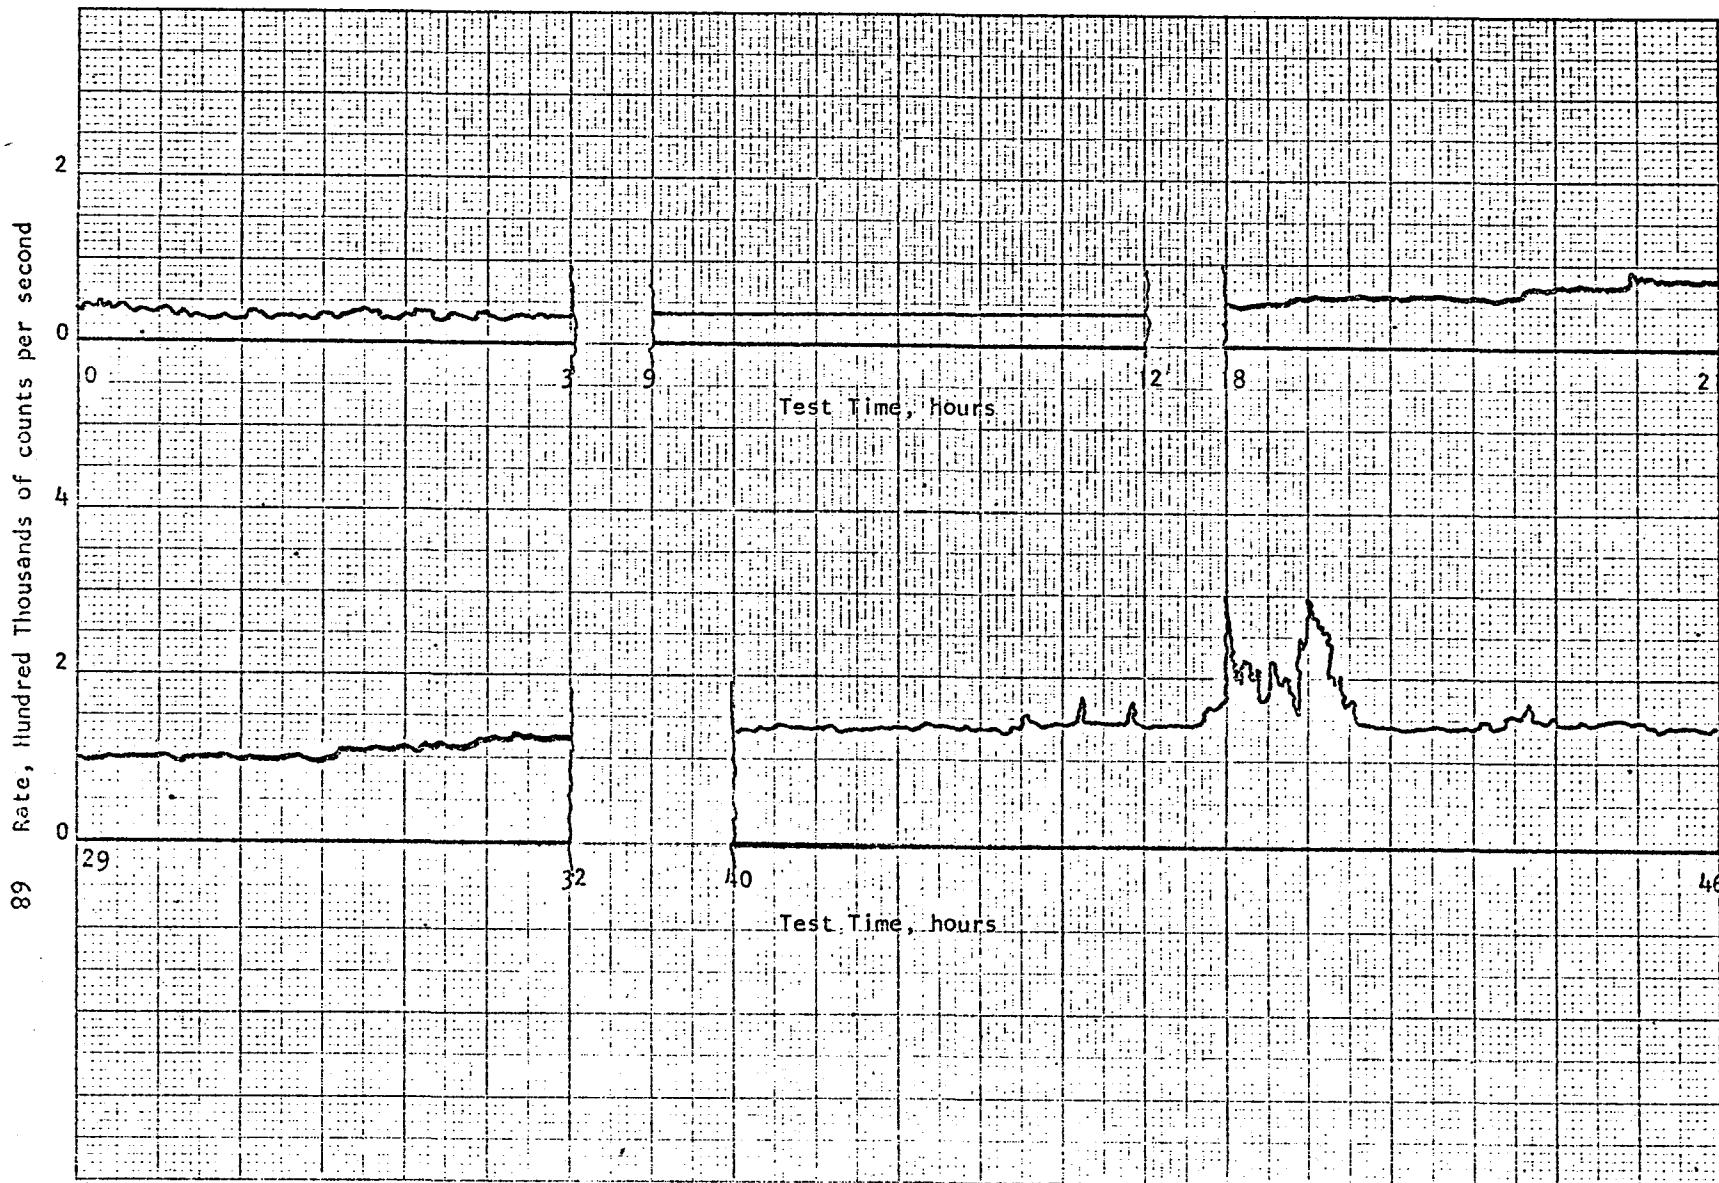
Figure 26 - Reproduction of sections of count rate data from Endevco® Model D9202 Acoustic Emission/Stress Wave Sensor with Model 301 Totalizer on fatigue test run number four, bearing number 10.

Test run number four produced results using a bearing in new-unfaulted condition. After 43 hours, the Model D9202 count rate showed a large increase for about one hour and then returned to a relatively normal level, see Figure 26. The peak detected signal and the envelope detected Model D9202 signal also showed an increase in this time period. The peak signal level of the Model D9202 Sensor output increased over the

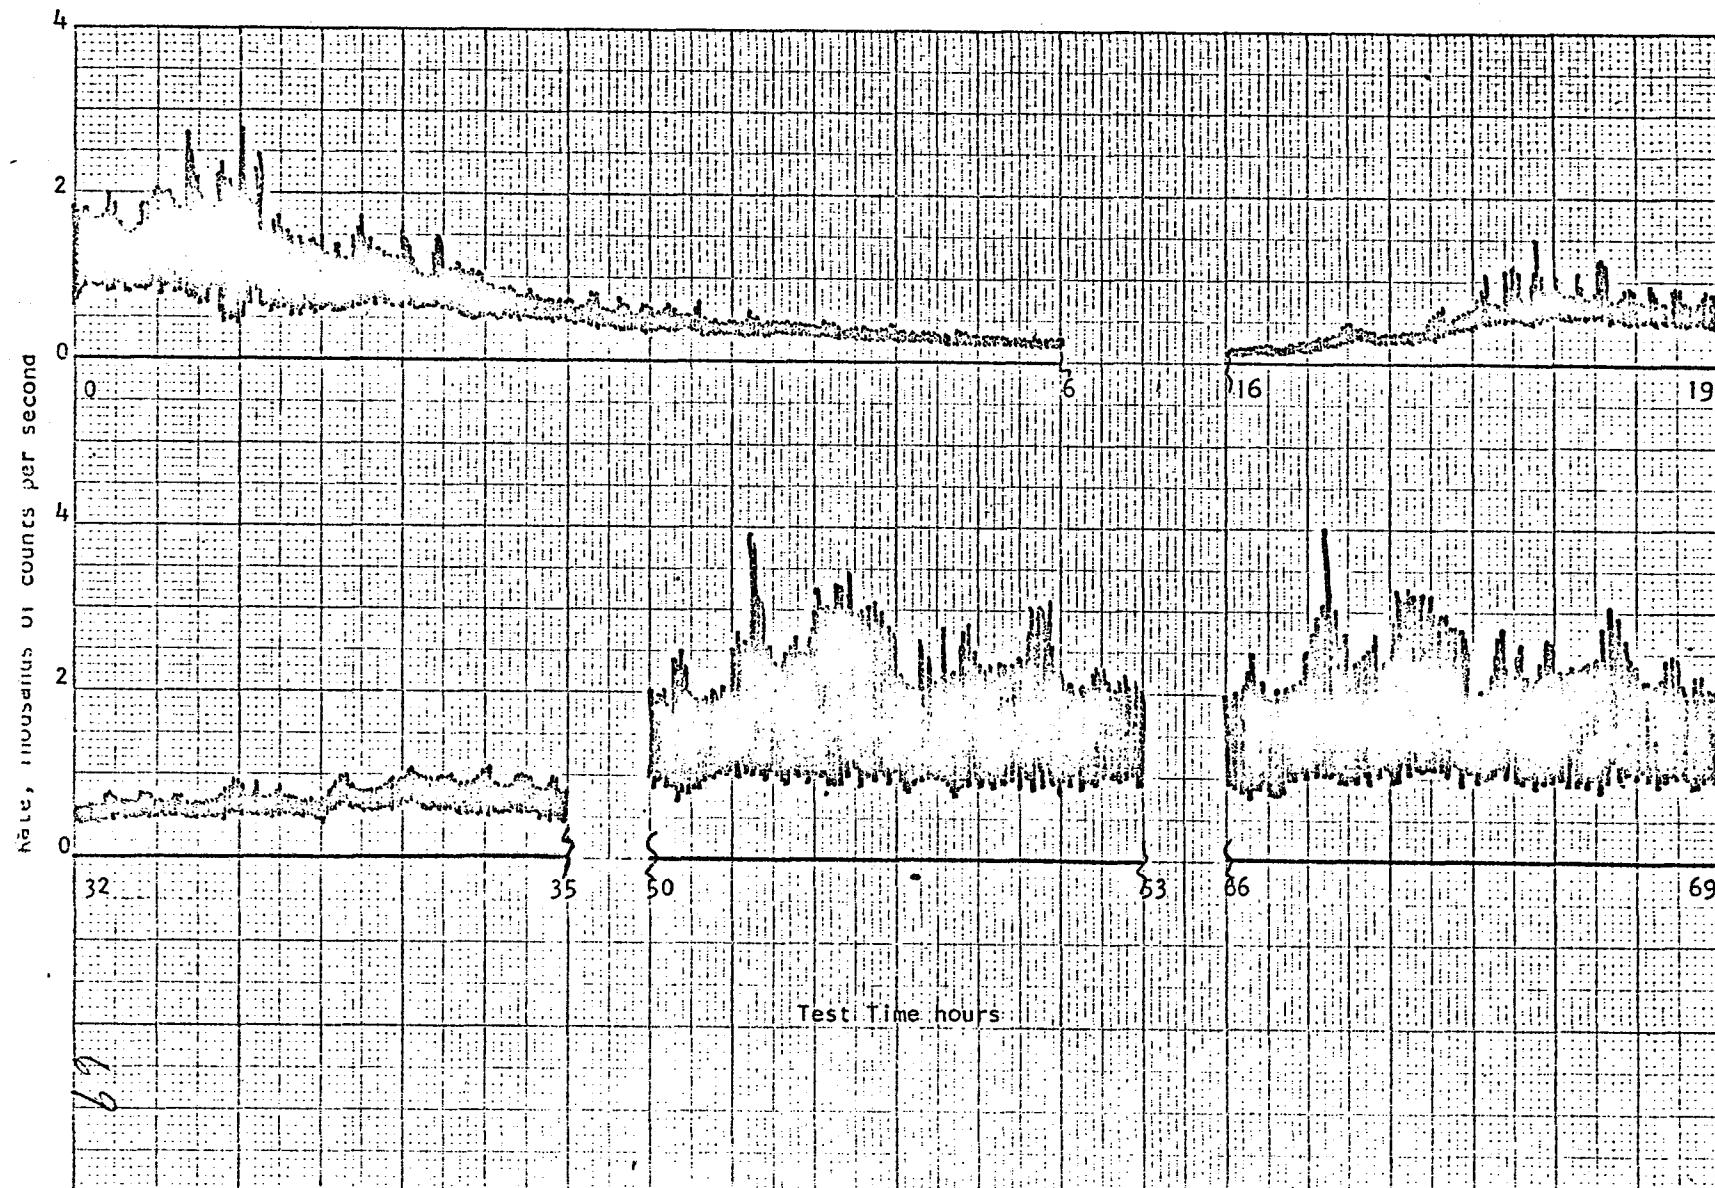
Figure 27a - Reproduction of Sections of count rate data from Endevco® Model D9202 Acoustic Emission/Stress Wave Sensor with M.del 301 Totalizer on fatigue test run number six, bearing number 17. (See Figure 27b for conclusion of test)

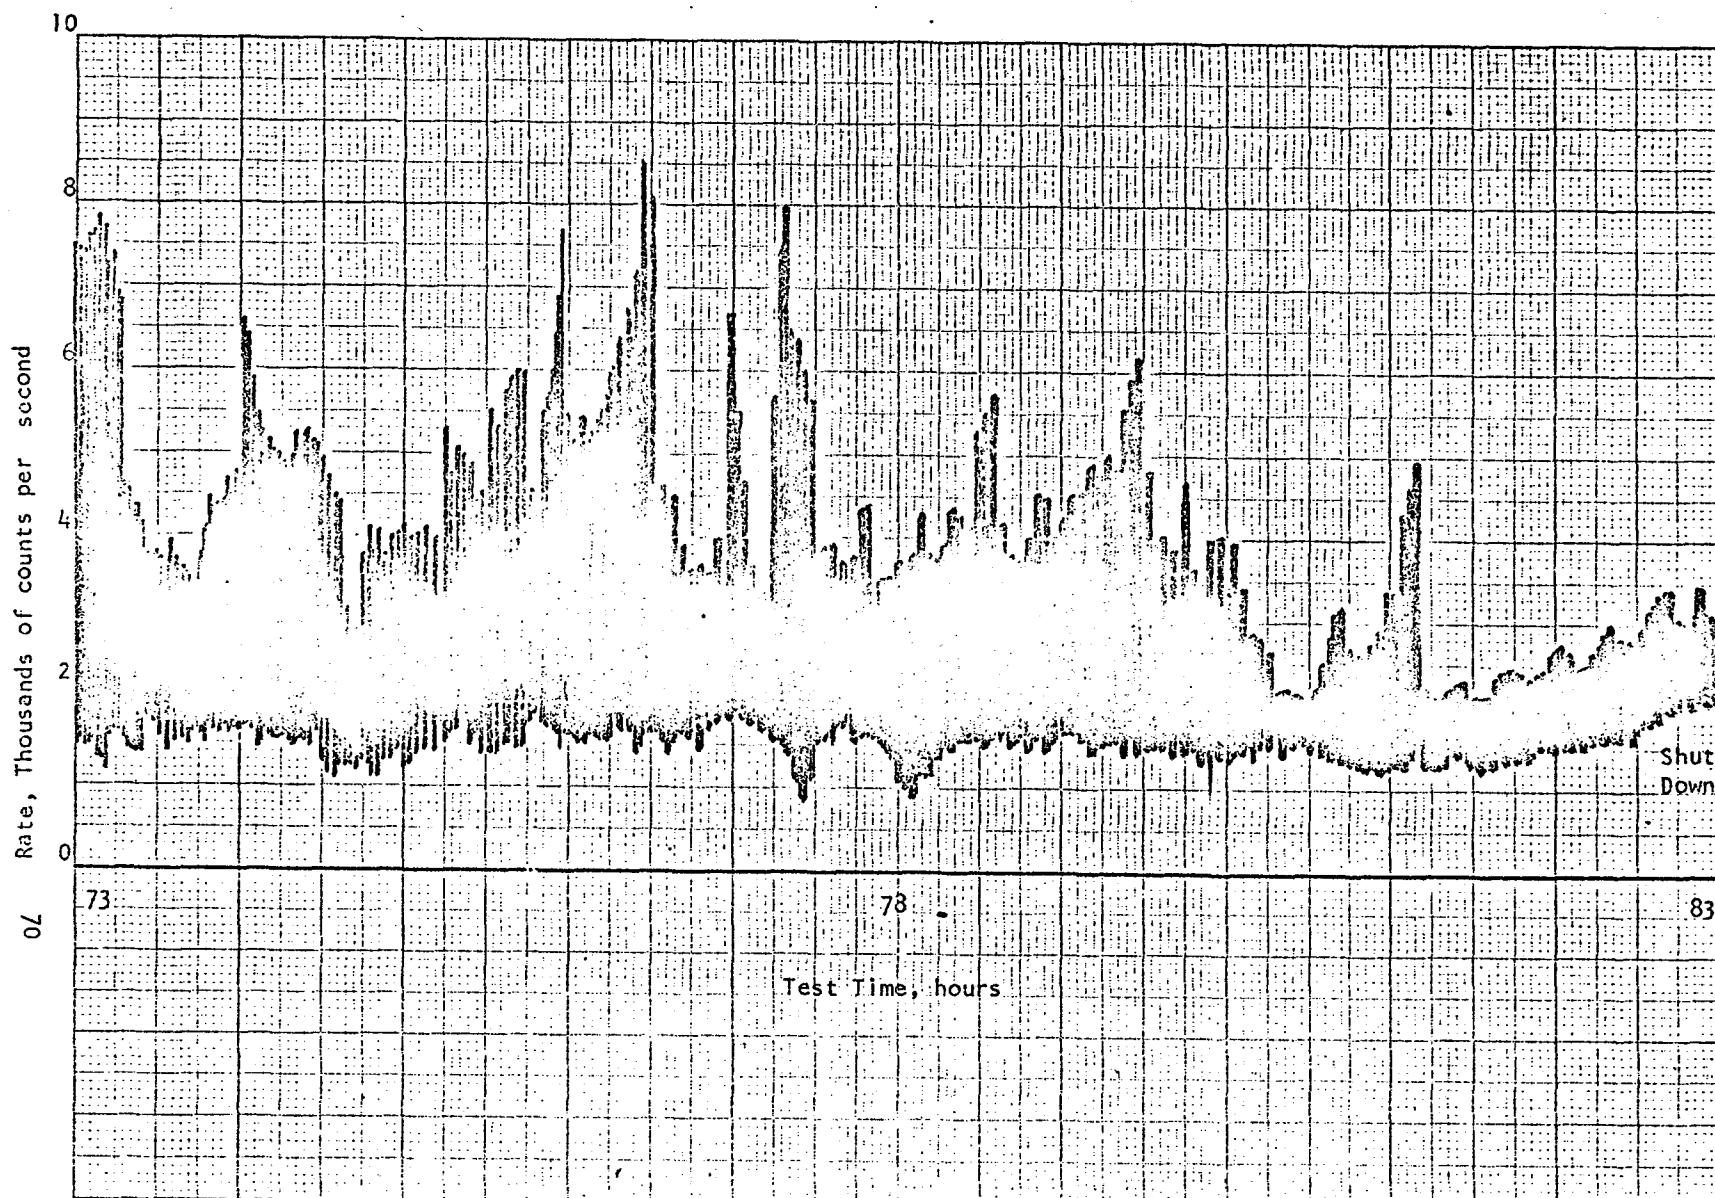
Figure 27b - Reproduction of final shut down count rate data from Endevco<sup>®</sup> Model D9202 Acoustic Emission/Stress Wave Sensor with Model 301 Totalizer on fatigue test run number six, bearing number 17.

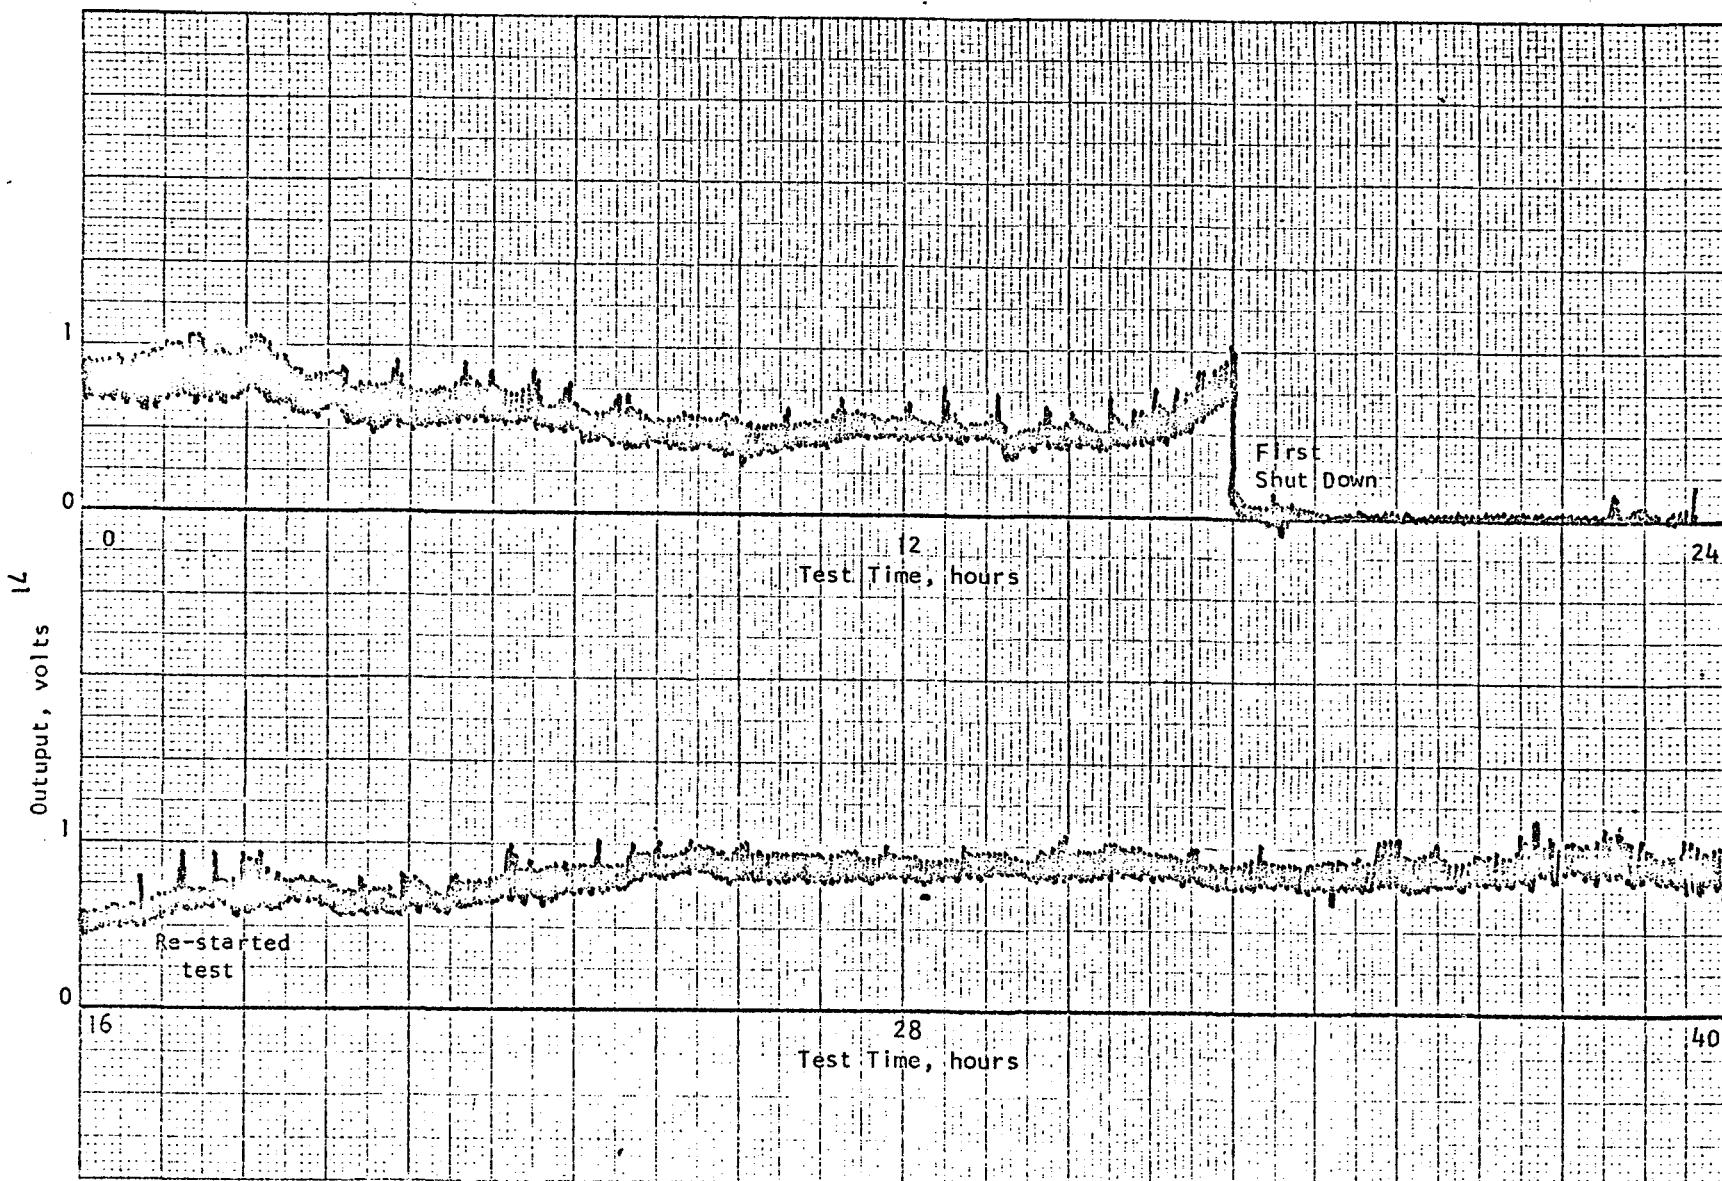
Figure 28a. - Reproduction of peak envelope detected data from Endevco<sup>®</sup> Model D9202 Acoustic Emission/ Stress Wave Sensor on fatigue test run number six, bearing number 17. See Figure 28 b for conclusion of tests.

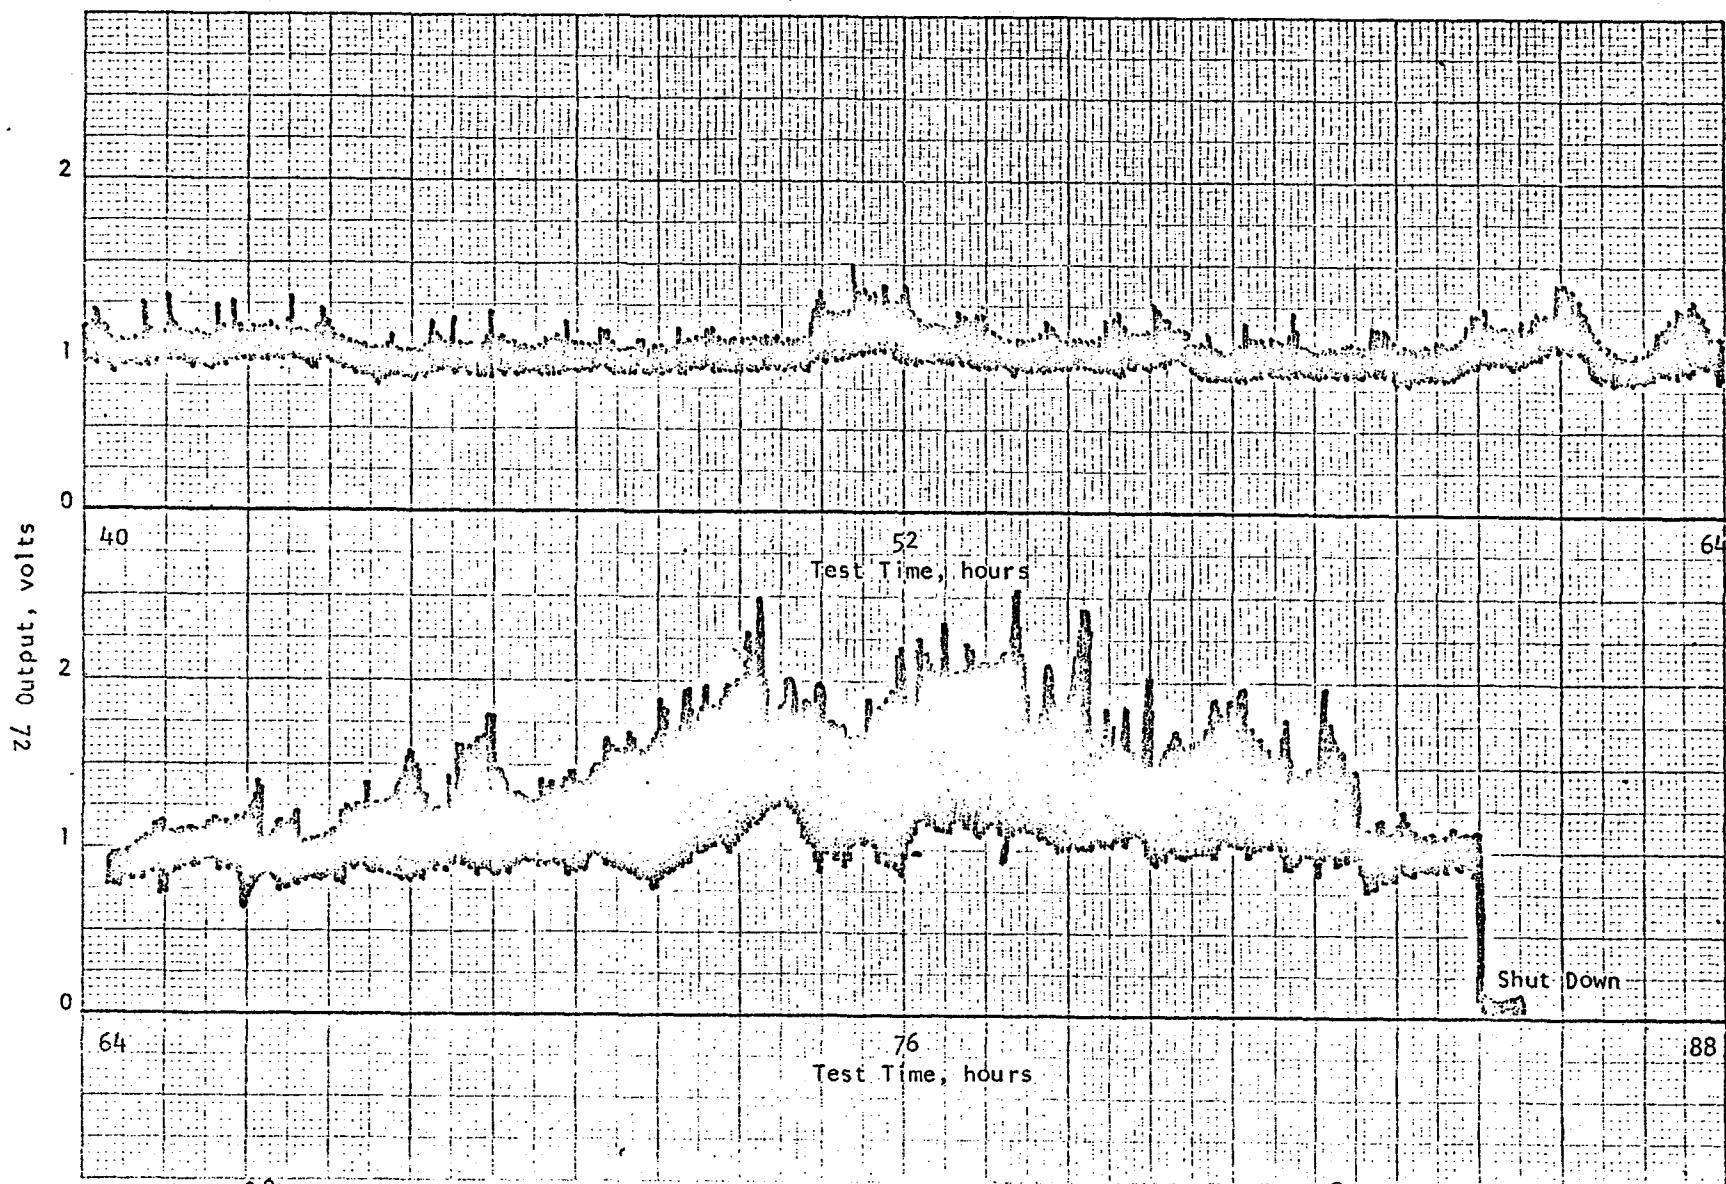
Figure 28b. Conclusion of tests. Reproduction peak envelope detected data from Endevco® Model D9202 Acoustic Emission/Stress Wave Sensor on fatigue test run number six, bearing number 17.

A careful examination of bearing number 17 on fatigue test number 6 showed a small pit in the outer race about 0.0002 inch deep by 0.002 inch diameter. This was similar to that found in bearing number 10. In addition, there were many very small imperfections, perhaps one tenth this depth around the path of the ball on the races. On the inner race, a streak appeared as if ball skidding had occurred. The depth of the skid marks were very small but extended for 0.5 inch at a slight angle to the travel of the ball on the race. The depth of the marks are extremely shallow, about  $20 \mu$  inch and may not be of much significance at this time. It is possible that test continuation would cause a large fault to be generated under these circumstances as occurred with the small scribe line on bearing number 13.

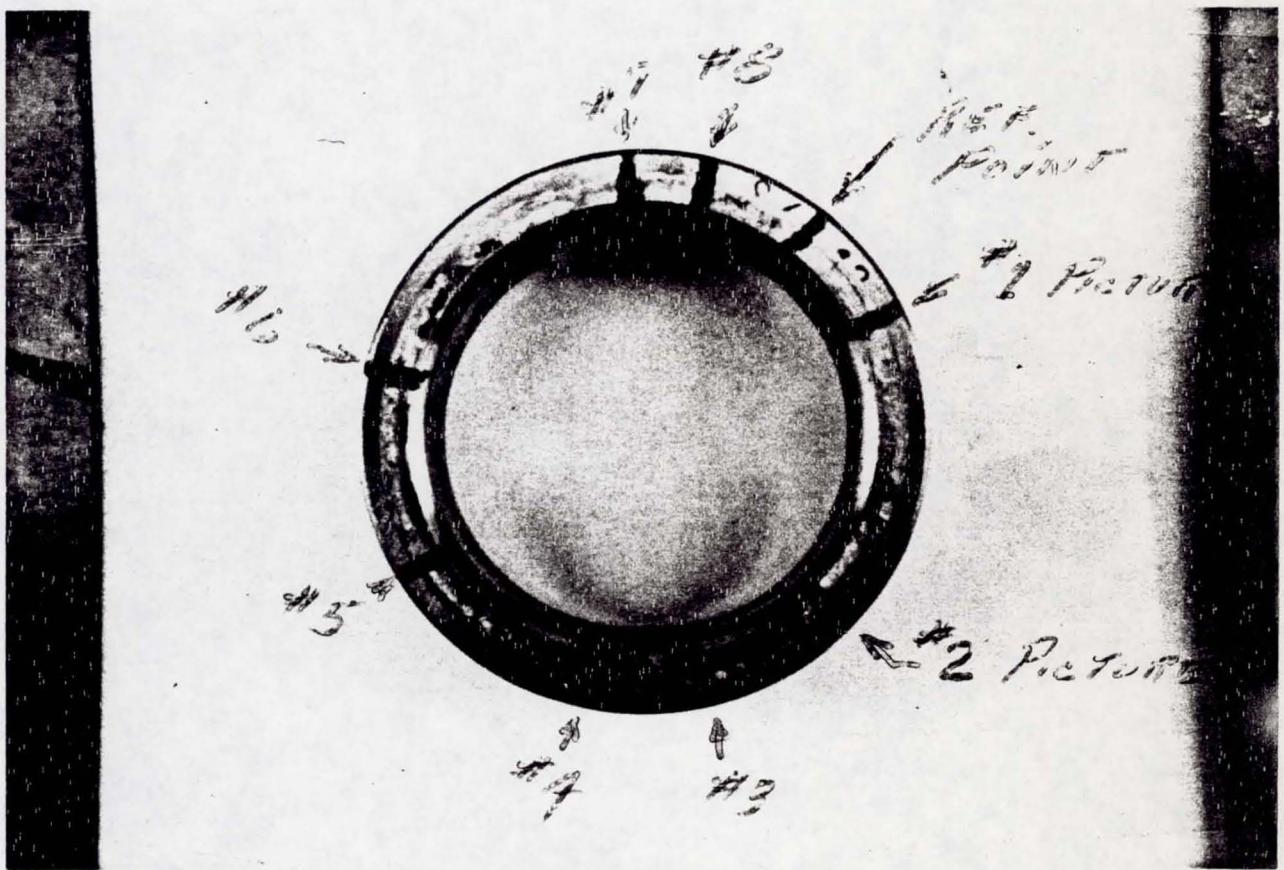
Bearing number 13 was photographed after disassembly to show the extent and character of the damage to the faulted members. The results are in evidence in Figures 29 to 36. As discussed before, the test ran longer than desired since the automatic shut down was referenced to the broadband

Figure 29 - Inner race from bearing number 13 after completion of fatigue test number one showing the positions of major area of damage. (approx. 1.5X)

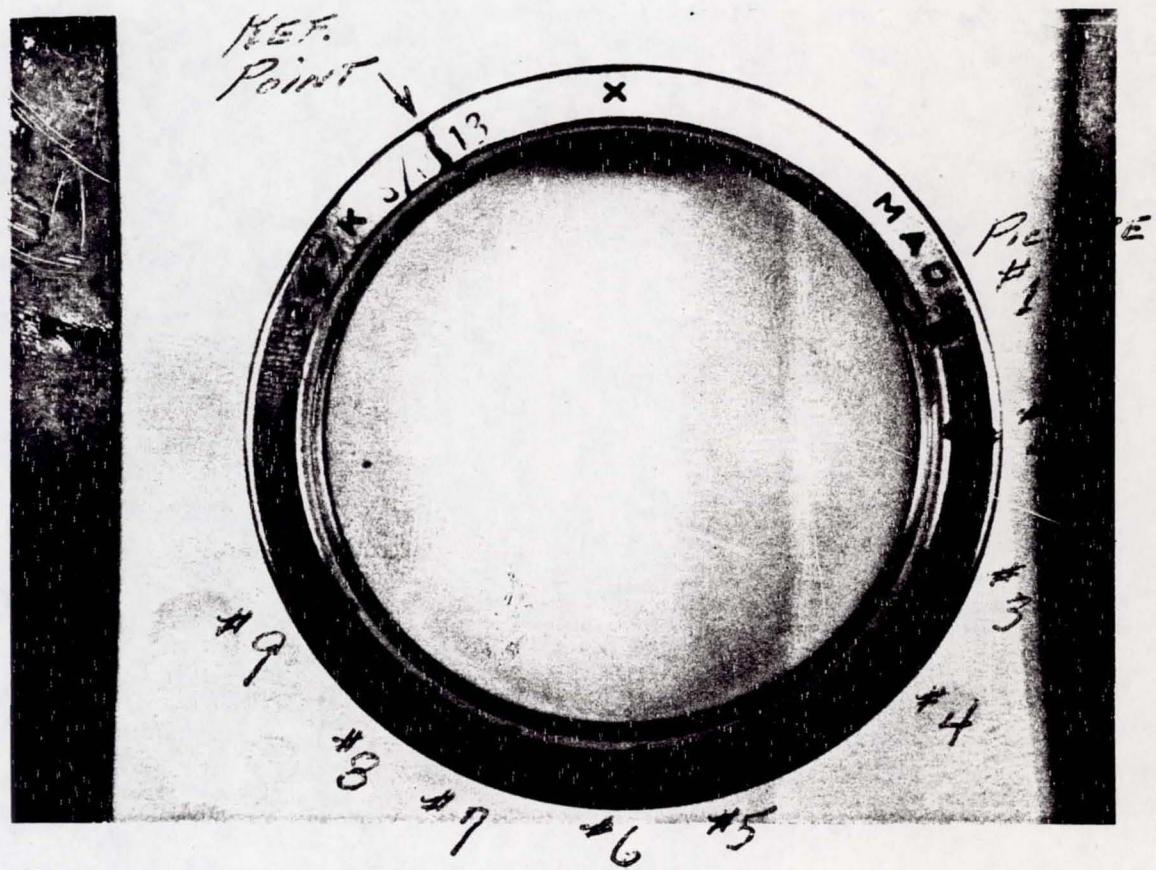
Figure 30 - Outer race from bearing number 13 after completion of fatigue test number one showing the positions of major areas of damage. (approx. 1.3X)

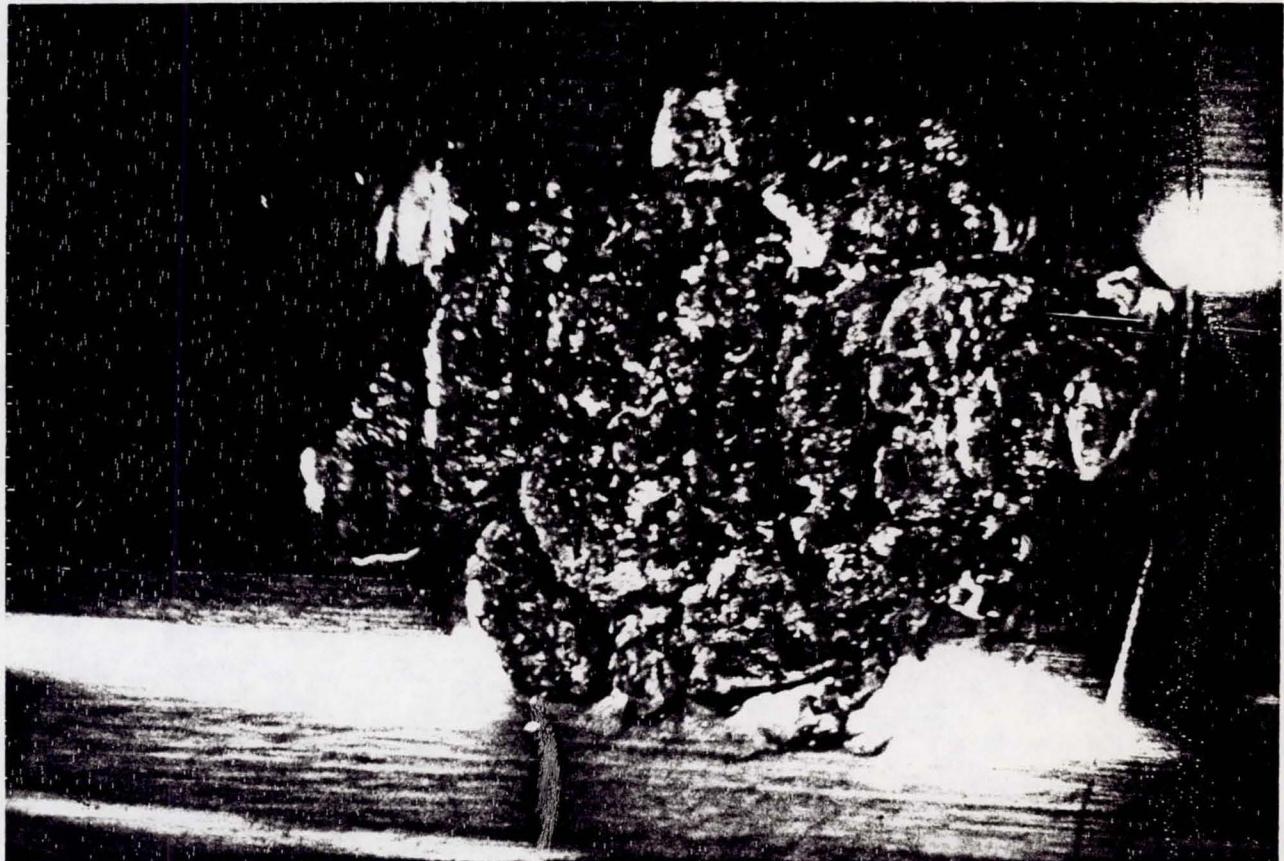
Figure 31 - Spalled area of inner race of bearing number 13,  
near the scribed fault line after completion of  
fatigue test. (approx. 20X)

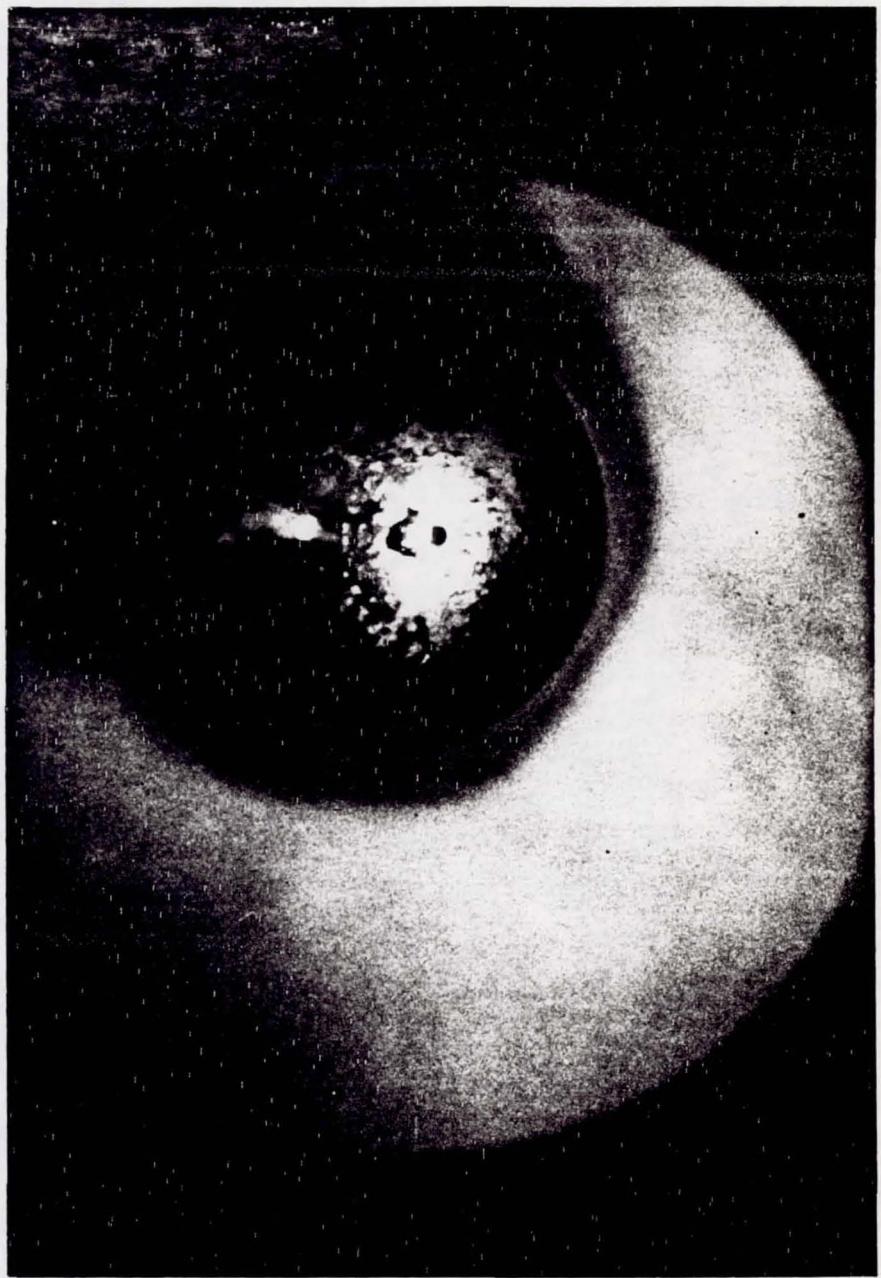
Figure 36 - Ball fault from bearing number 13 after completion of fatigue test number one.  
(approx. 5X)

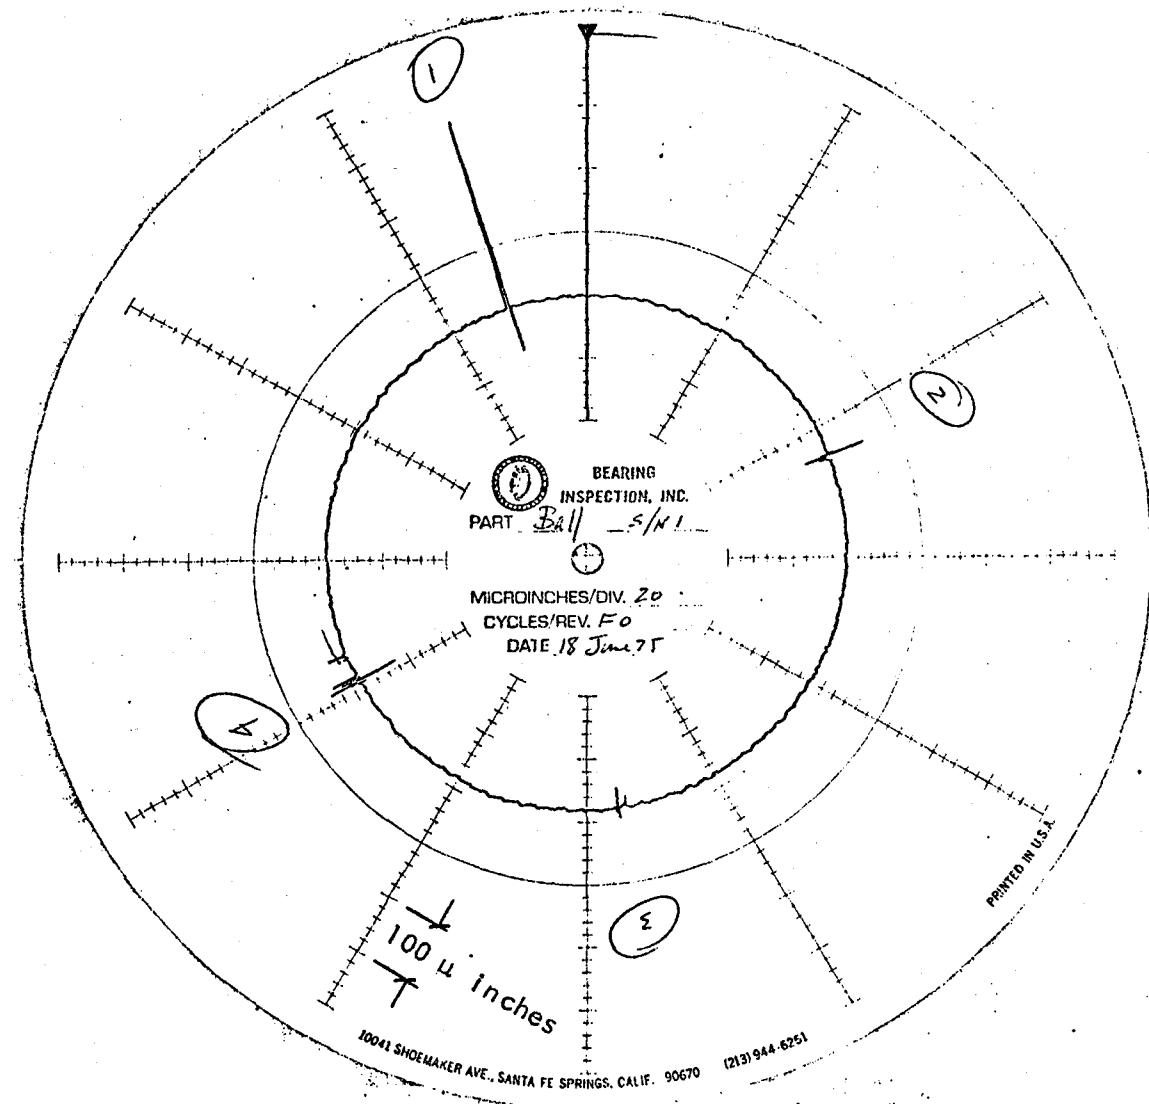
Figure 3-1a - Profilometer measurement of the fault locations scribed into one ball of bearing S/N 1.
